## CASE STUDY

# Ground investigation for Creswell Viaducts widening on M6 motorway

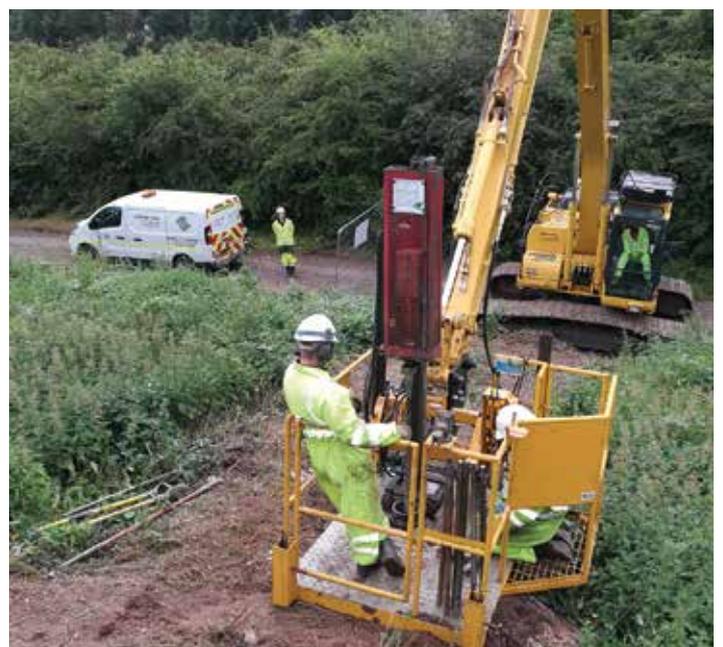
Dynamic probing was carried out on the slope from a working platform fitted to the boom. Using the long-reach excavator enabled probing to be undertaken at most points on the embankment slopes and made relocating the equipment along a line for each successive test simple. It also removed the stability risks and anchoring requirements inherent to slope-climbing drilling rigs and avoided the need to access the work areas from above via the motorway carriageway.

A long-reach, 20-t, Komatsu PC 220 LC tracked excavator specially modified to enable different investigation apparatus and working platforms to be connected to the boom was used to provide access for plant and personnel to work on the embankment slopes. The slopes were of variable inclination and height, but were estimated to be more than 40° at their steepest and at or beyond the practical limit of most slope-climbing equipment.

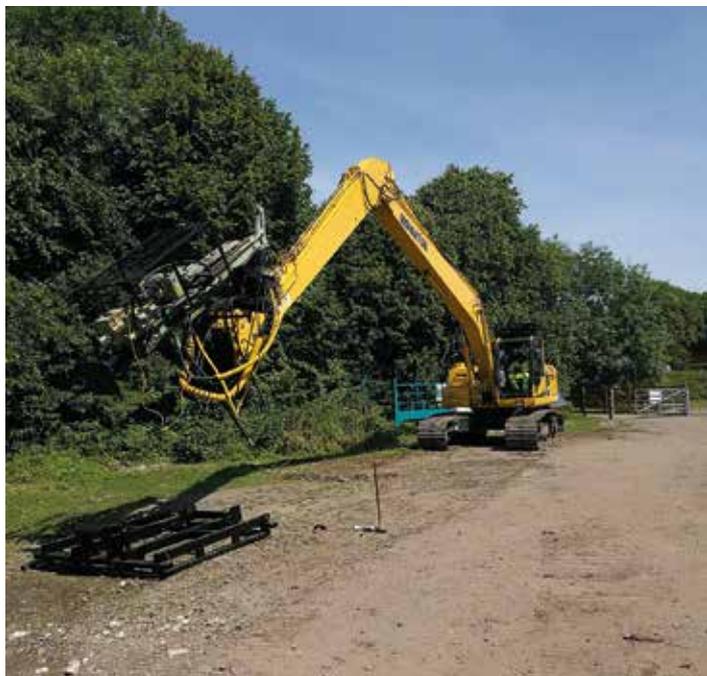
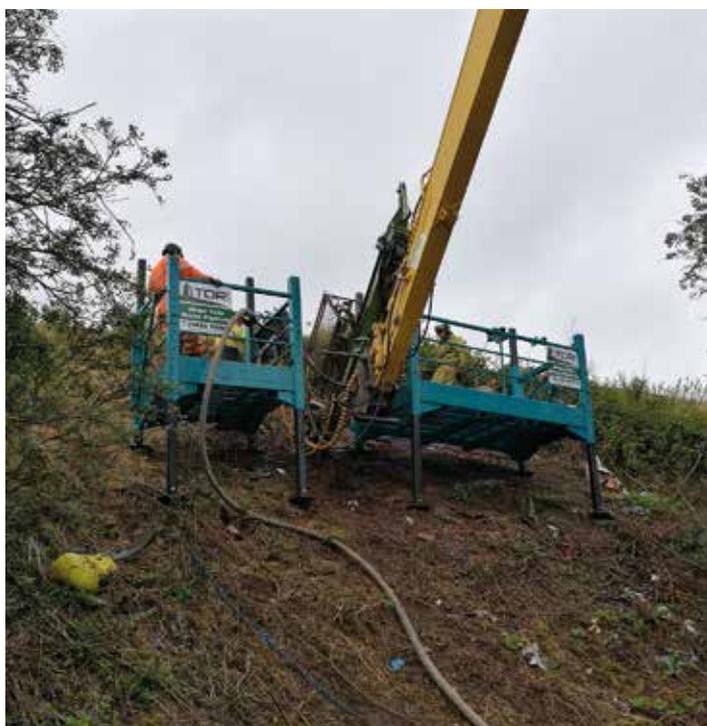
The same excavator boom was then fitted with a modified rotary drilling rig mast to enable the inclined boreholes to be progressed by dynamic sampling and rotary coring techniques through the embankments and stabilised soil walls within. Working platforms were lifted onto the slopes by the excavator and anchored in position at each hole location to provide access for the drilling team and to hold the equipment and materials required. The borehole lengths ranged from 4 to 8.8 m at inclinations ranging from 18.9 to 43° from the horizontal.
